Arboricultural Consultancy for Lloyds Bank

Insured	Mrs Ellen Thomson	Address	Greymartin, Backworth Lane, Newcastle Upon Tyne, NE27 0AL		
Client	Subsidence Management Services	Contact	Manjula Panchal	Claim No.	IFS-LBG-SUB-18-0079347
ES Ref	SA-242385	Consultant	Will Rickerby	Contact No.	0330 380 1036
Report Date	15/01/2019

Scope of Report: To survey the property and determine significant vegetation contributing to subsidence damage, make recommendation for remedial action and assess initial mitigation and recovery prospects. The survey does not make an assessment for decay or hazard evaluation.

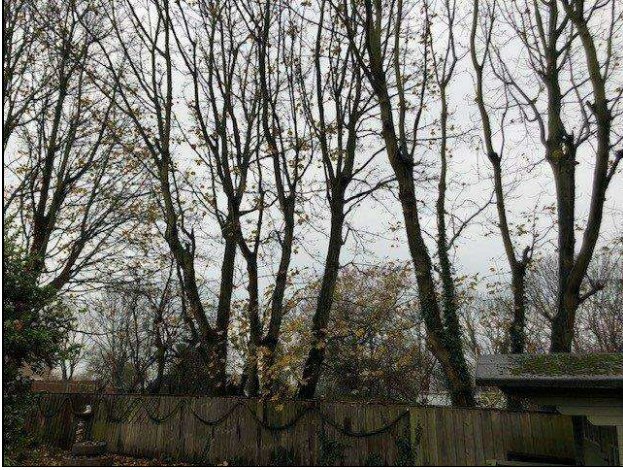
TG2- Acer

Tree No.	Species	Age Cat	Approx. Height (m)	Distance to Building (m) *	Ownership	Action	Requirement
TG2	Acer	1	14	7.6	A - Third Party	Action to avoid future risk	Do not allow to exceed current dimensions by way of regular pruning.

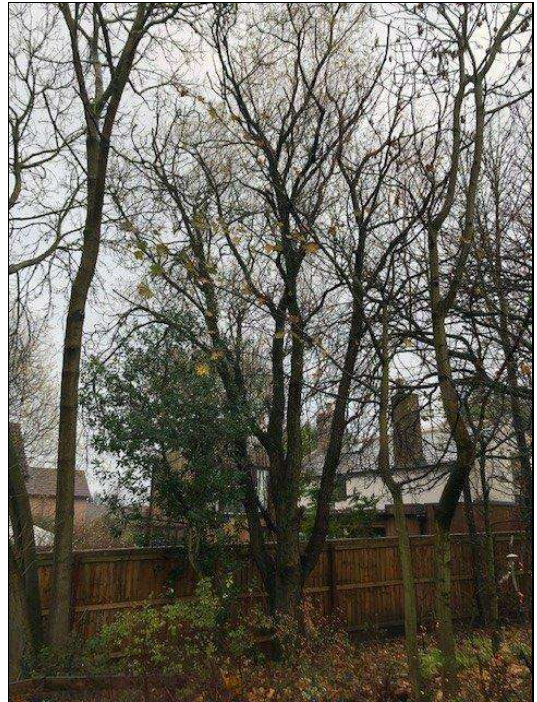
TG3 - Acer

TG3	Acer	1	14	7.3	C - Insured	Remove	Remove close to ground level; do not treat stump due to translocation risk. Where such a risk exists, we advise that any emergent regrowth is removed annually.
TG4	Acer	1	14	5.7	C - Insured	Remove	Remove close to ground level; do not treat stump due to translocation risk. Where such a risk exists, we advise that any emergent regrowth is removed annually.
TG5	Acer	1	14	5.2	C - Insured	Remove	Remove close to ground level; do not treat stump due to translocation risk. Where such a risk exists, we advise that any emergent regrowth is removed annually.

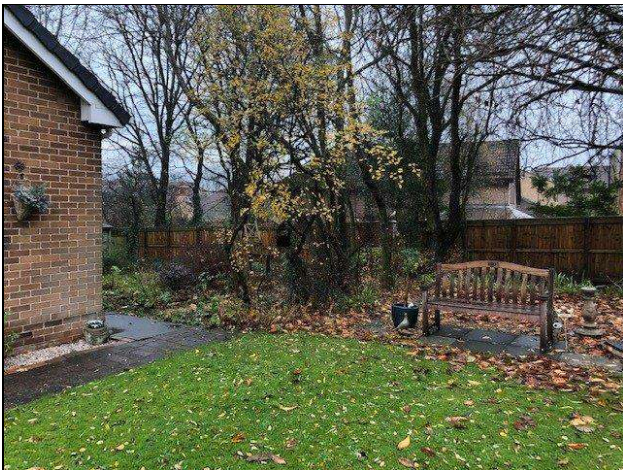
Our survey of the site identified T1 (Willow (Goat)) and TG1 (Mixed Species Group), given their position relative to the damage it is our opinion that the roots identified within TP/BH2 will emanate from this vegetation.

TG1 - Mixed species

Removal of TG1 (Mixed species Group), T1 (Willow), T2 (Ash), T3 (Acer), T4 (Acer), TG3 (Mixed Species Group), TG4 (Acer) and TG5 (Acer) will offer the most certain and reliable arboricultural solution likely to restore long-term stability.

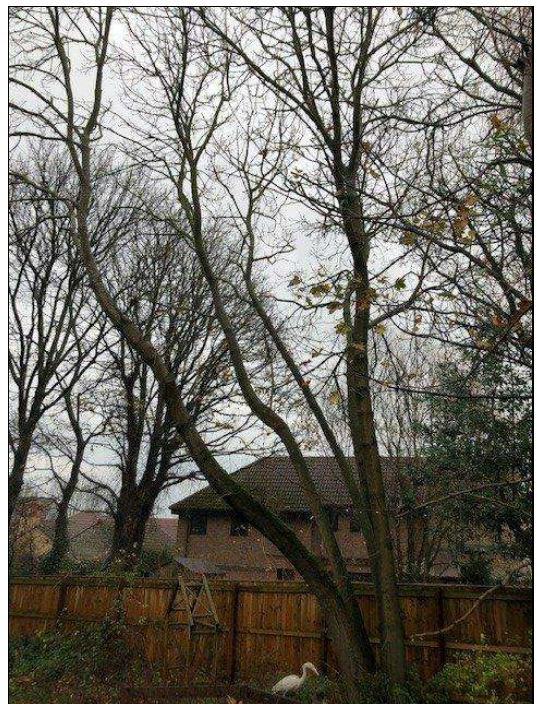
T2 - Ash

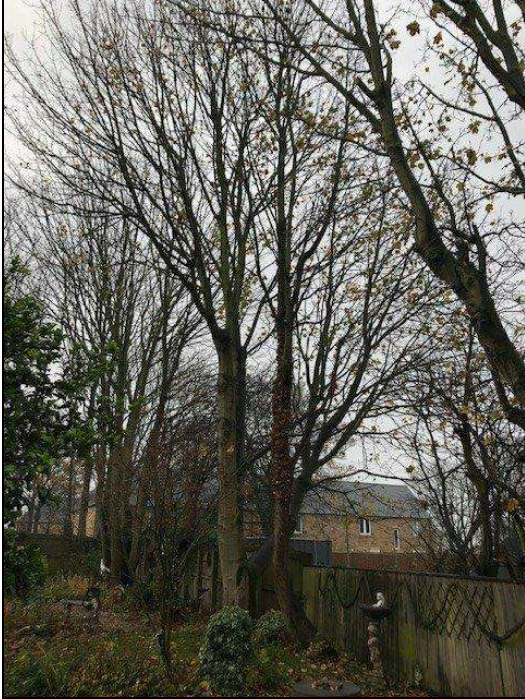
The Acer spp roots recovered within TP/BH1 will, on balance derive from the Acers (T3, T4, TG3 & TG4).

TG3 - Acer

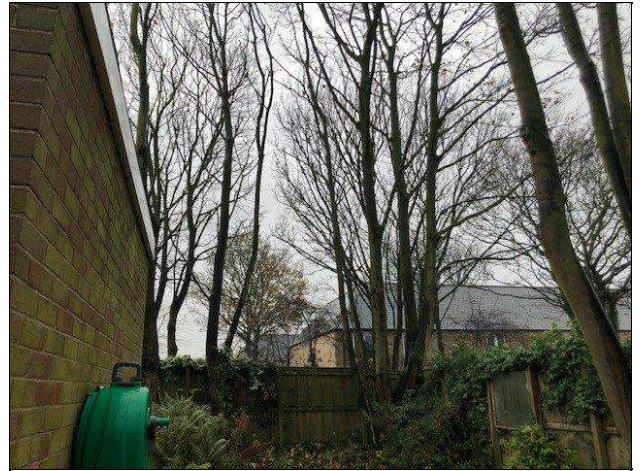
With regards to the broadleaved species roots (too juvenile for positive identification), it is our opinion that these will on balance derive from the Acer (T4)

T4 - Acer

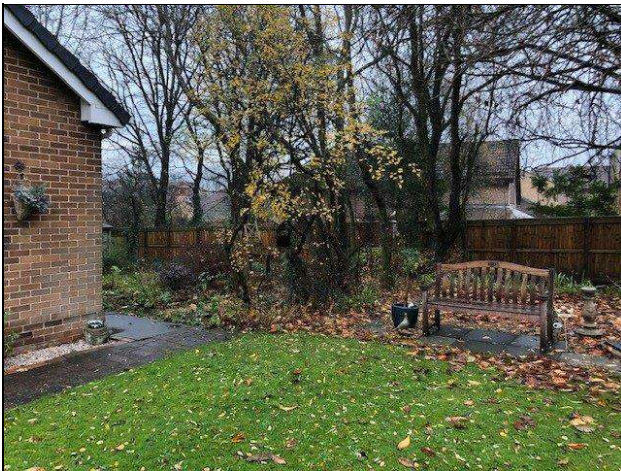
T1 - Willow

Tree No.	Species	Age Cat	Approx. Height (m)	Distance to Building (m) *	Ownership	Action	Requirement
T1	Willow (Goat)	1	12.3	8.9	C - Insured	Remove	Remove close to ground level; do not treat stump due to translocation risk. Where such a risk exists, we advise that any emergent regrowth is removed annually.
T2	Ash	1	14.5	8.8	C - Insured	Remove	Remove close to ground level; do not treat stump due to translocation risk. Where such a risk exists, we advise that any emergent regrowth is removed annually.
T3	Acer	1	14	4.5	C - Insured	Remove	Remove close to ground level; do not treat stump due to translocation risk. Where such a risk exists, we advise that any emergent regrowth is removed annually.
T4	Acer	1	14	8	C - Insured	Remove	Remove close to ground level; do not treat stump due to translocation risk. Where such a risk exists, we advise that any emergent regrowth is removed annually.
TG1	Mixed Species Group: Species include: Hawthorn, Acer, Elder.	1	7	1.7	C - Insured	Remove	Remove close to ground level; do not treat stump due to translocation risk. Where such a risk exists, we advise that any emergent regrowth is removed annually.

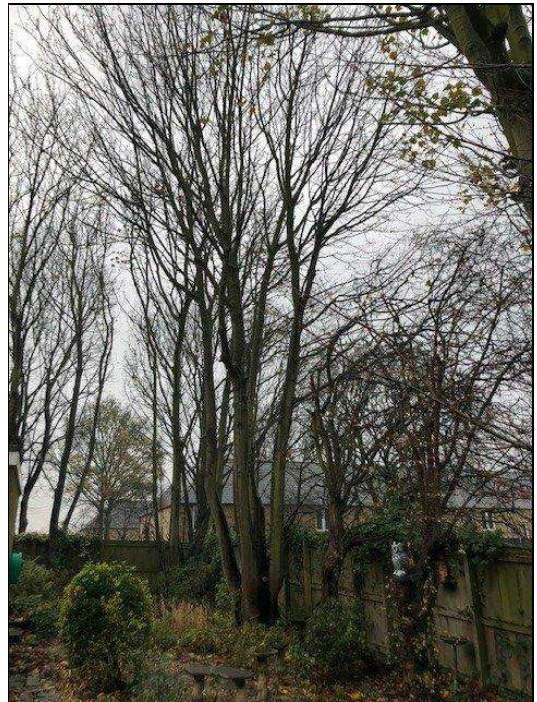
T3 - Acer
