# 18 Station Road Ash Tree Arboricultural Management Report July 2021

Produced for Mr Peter Bouchard  
By Jim Richardson BSc For. HND Arb.

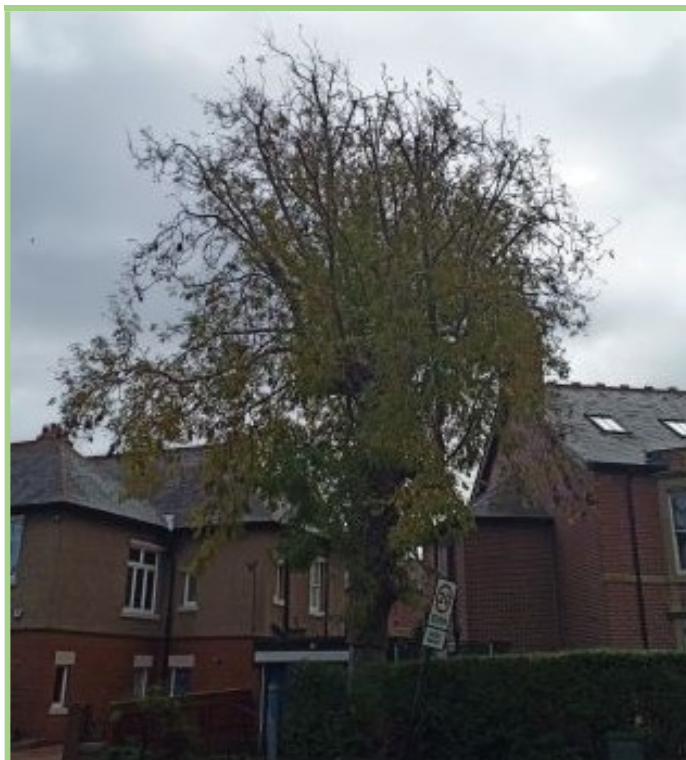
- 4.1. There Ash tree to the front of No 18 Station Road is showing signs of 'Ash Dieback'. Although there is still some good foliage cover in the lower crown the upper crown shows poor shoot formation, shoot dieback and weak distorted growth in the upper canopy. This is consistent with 'Ash Dieback' symptoms in mature trees.

#### Early Crown Dieback Autumn 2020

- 4.6. Given that this is a none-treatable disease it is recommended that the tree be removed at the soonest opportunity.
- 4.7. Continued dieback of the tree is likely to increase the risk it poses to adjacent people and property.

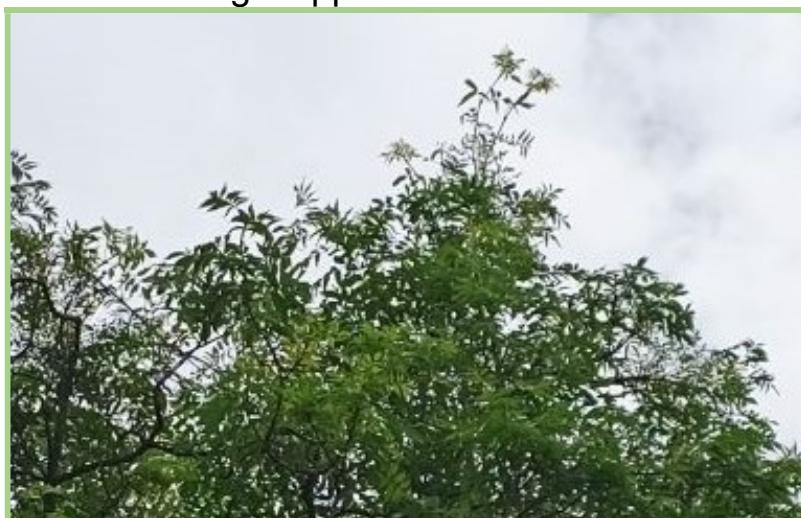
#### Terminal Shoots Withering - Upper Crown 2021

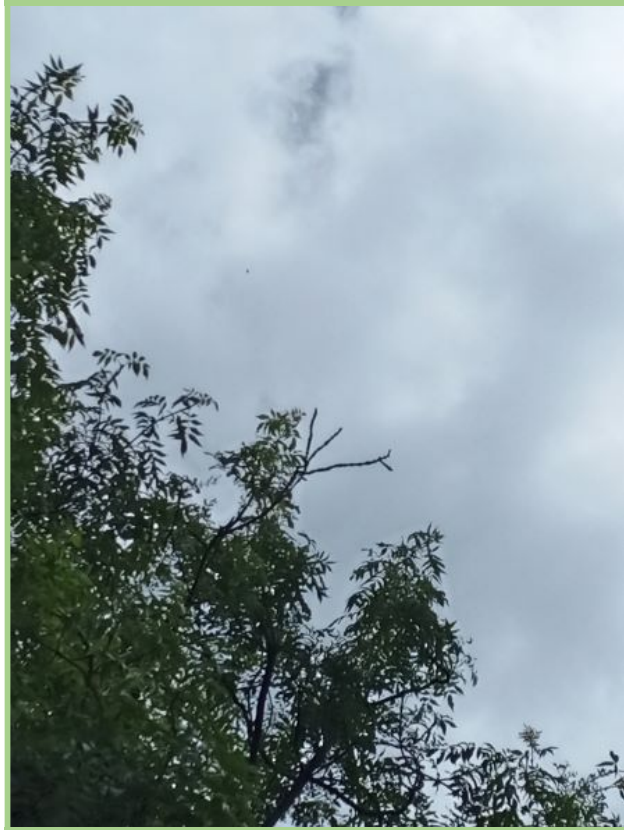
## Terminal Shoot Death 2021

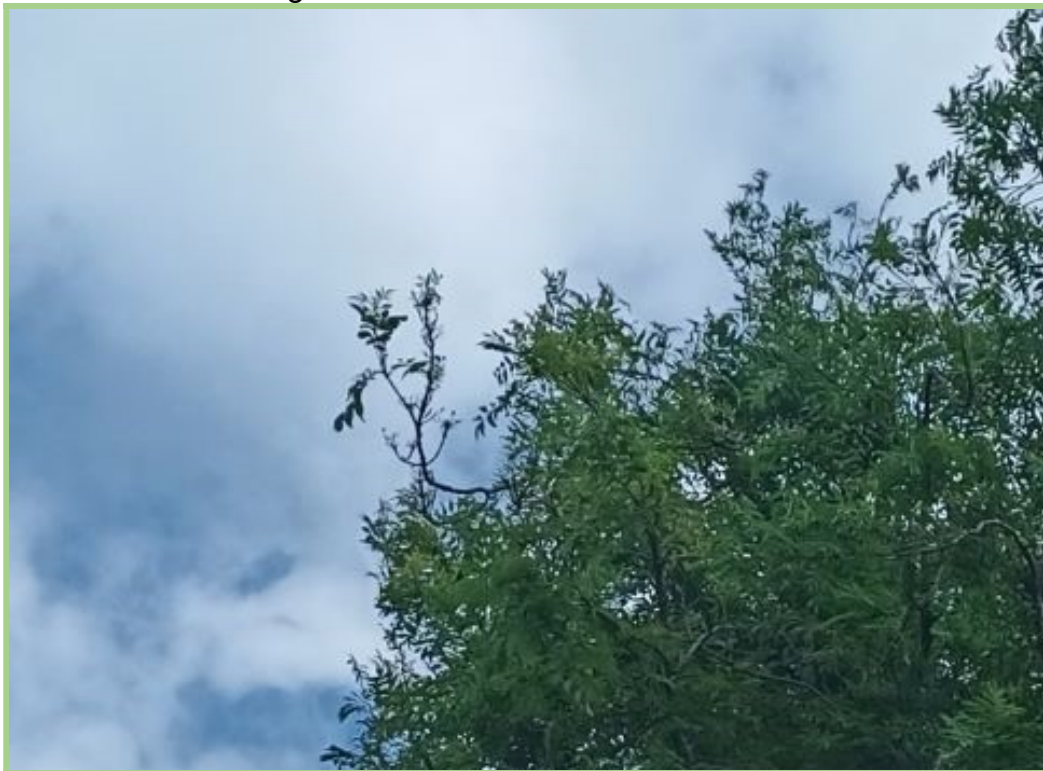
## Terminal Shoots Withering 2021

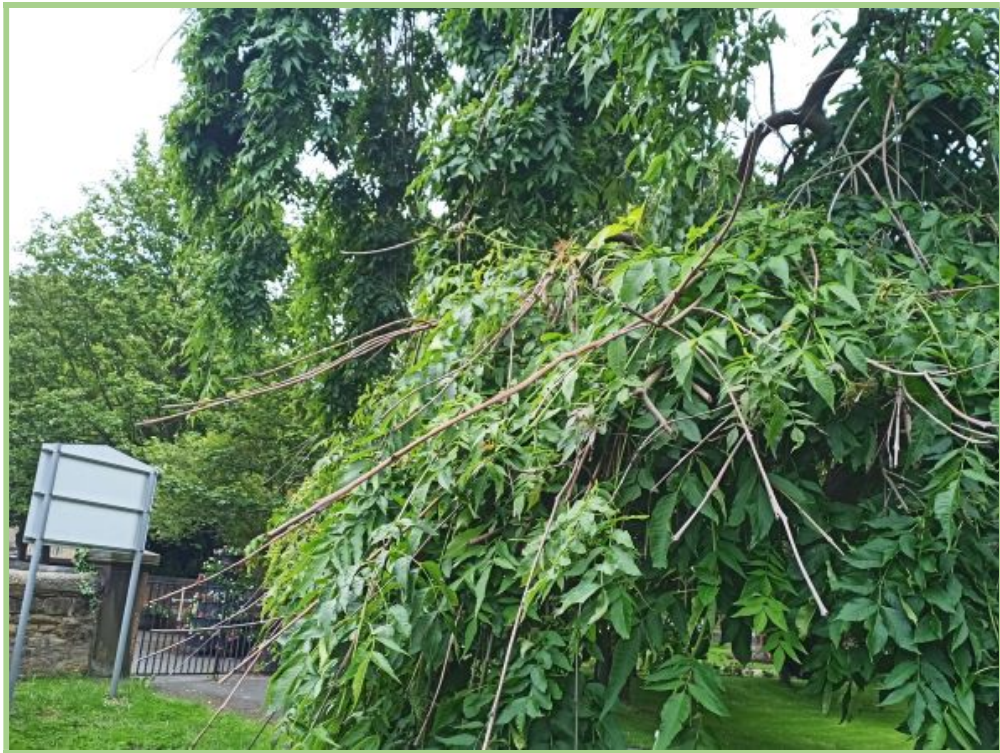
- para <https://www.forestresearch.gov.uk/tools-and-resources/fthr/pest-and-disease-resources/ash-dieback-hymenoscyphus-fraxineus/>*
- 4.4. The surrounding Ash trees on Station Road, Lyndhurst Road and those within the Benton Cemetery are also showing clear signs of 'Ash Dieback', with loss of terminal buds and all key signs of the disease.

Ash Dieback In Adjacent Trees - Benton Cemetery

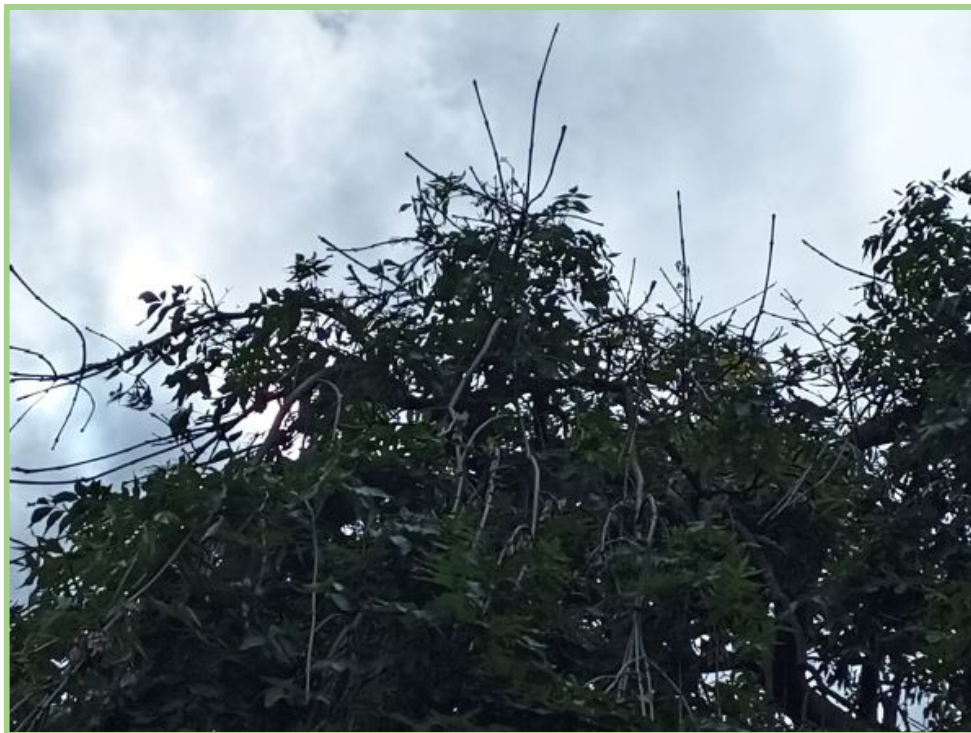
Ash Dieback In Adjacent Trees - Benton Cemetery

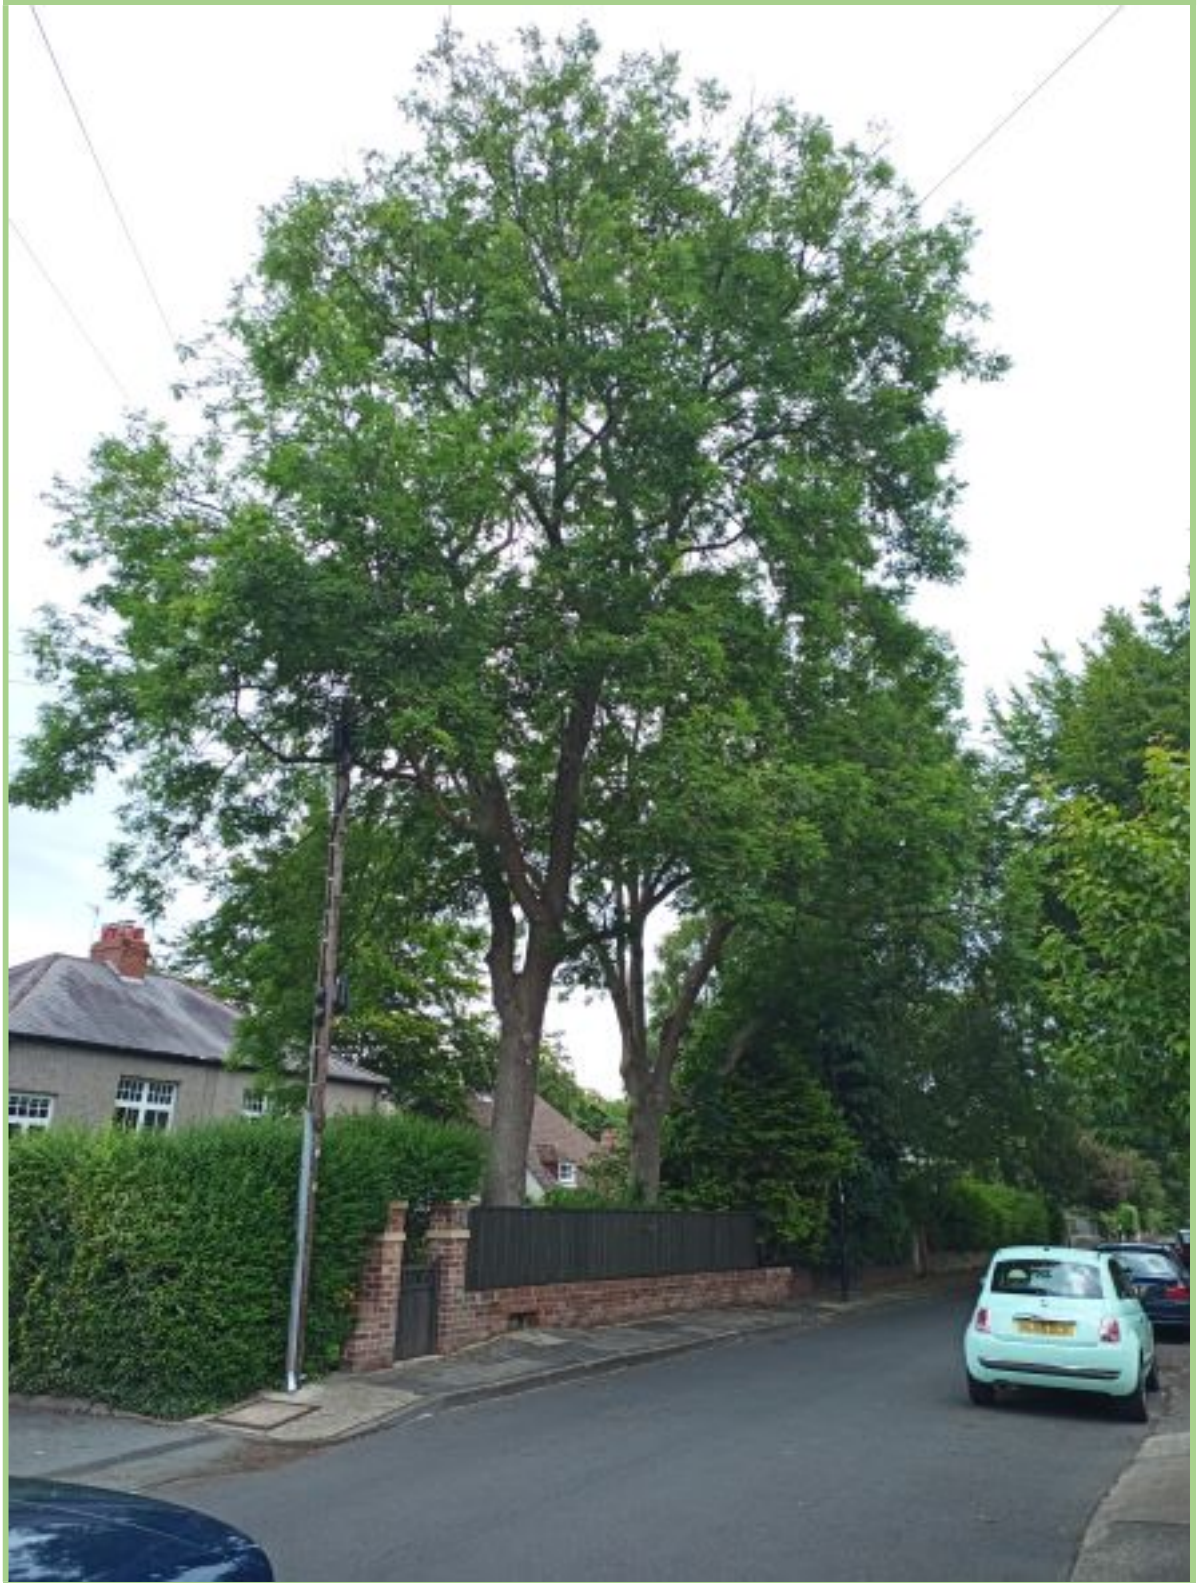
Ash Dieback In Adjacent Trees – Lyndhurst Road – Terminal Shoots Dying.
