Arboricultural Assessment -  
Inspection Of A Specified Ash Tree  
At 18 Station Road, Benton

For  
Mr P Bouchard

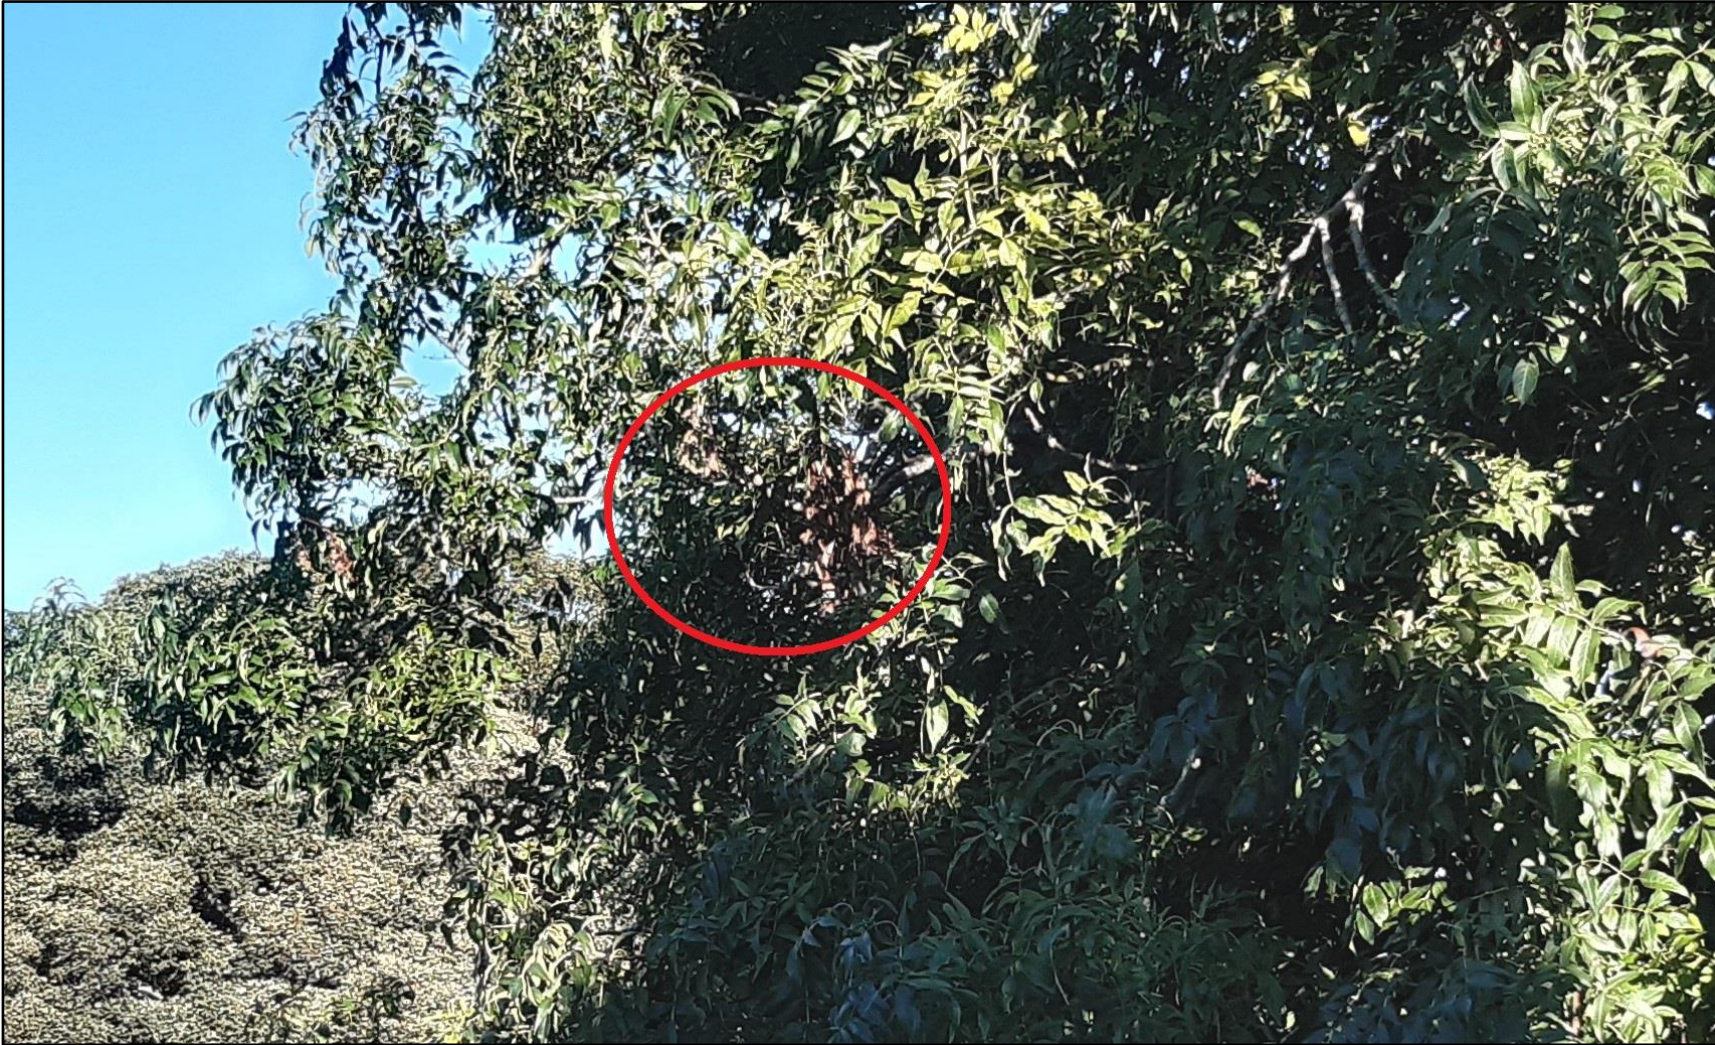
Inspection of the canopy reveals a number of clusters of blackened withered leaves which remain in situ (see photos 1-3 in appendix 1 of this document). Some of the examples are difficult to see in the photos due to light quality and their location in the canopy though they are easier to see on site.

Photo 1 – Blackened withered leaves hanging in the canopy

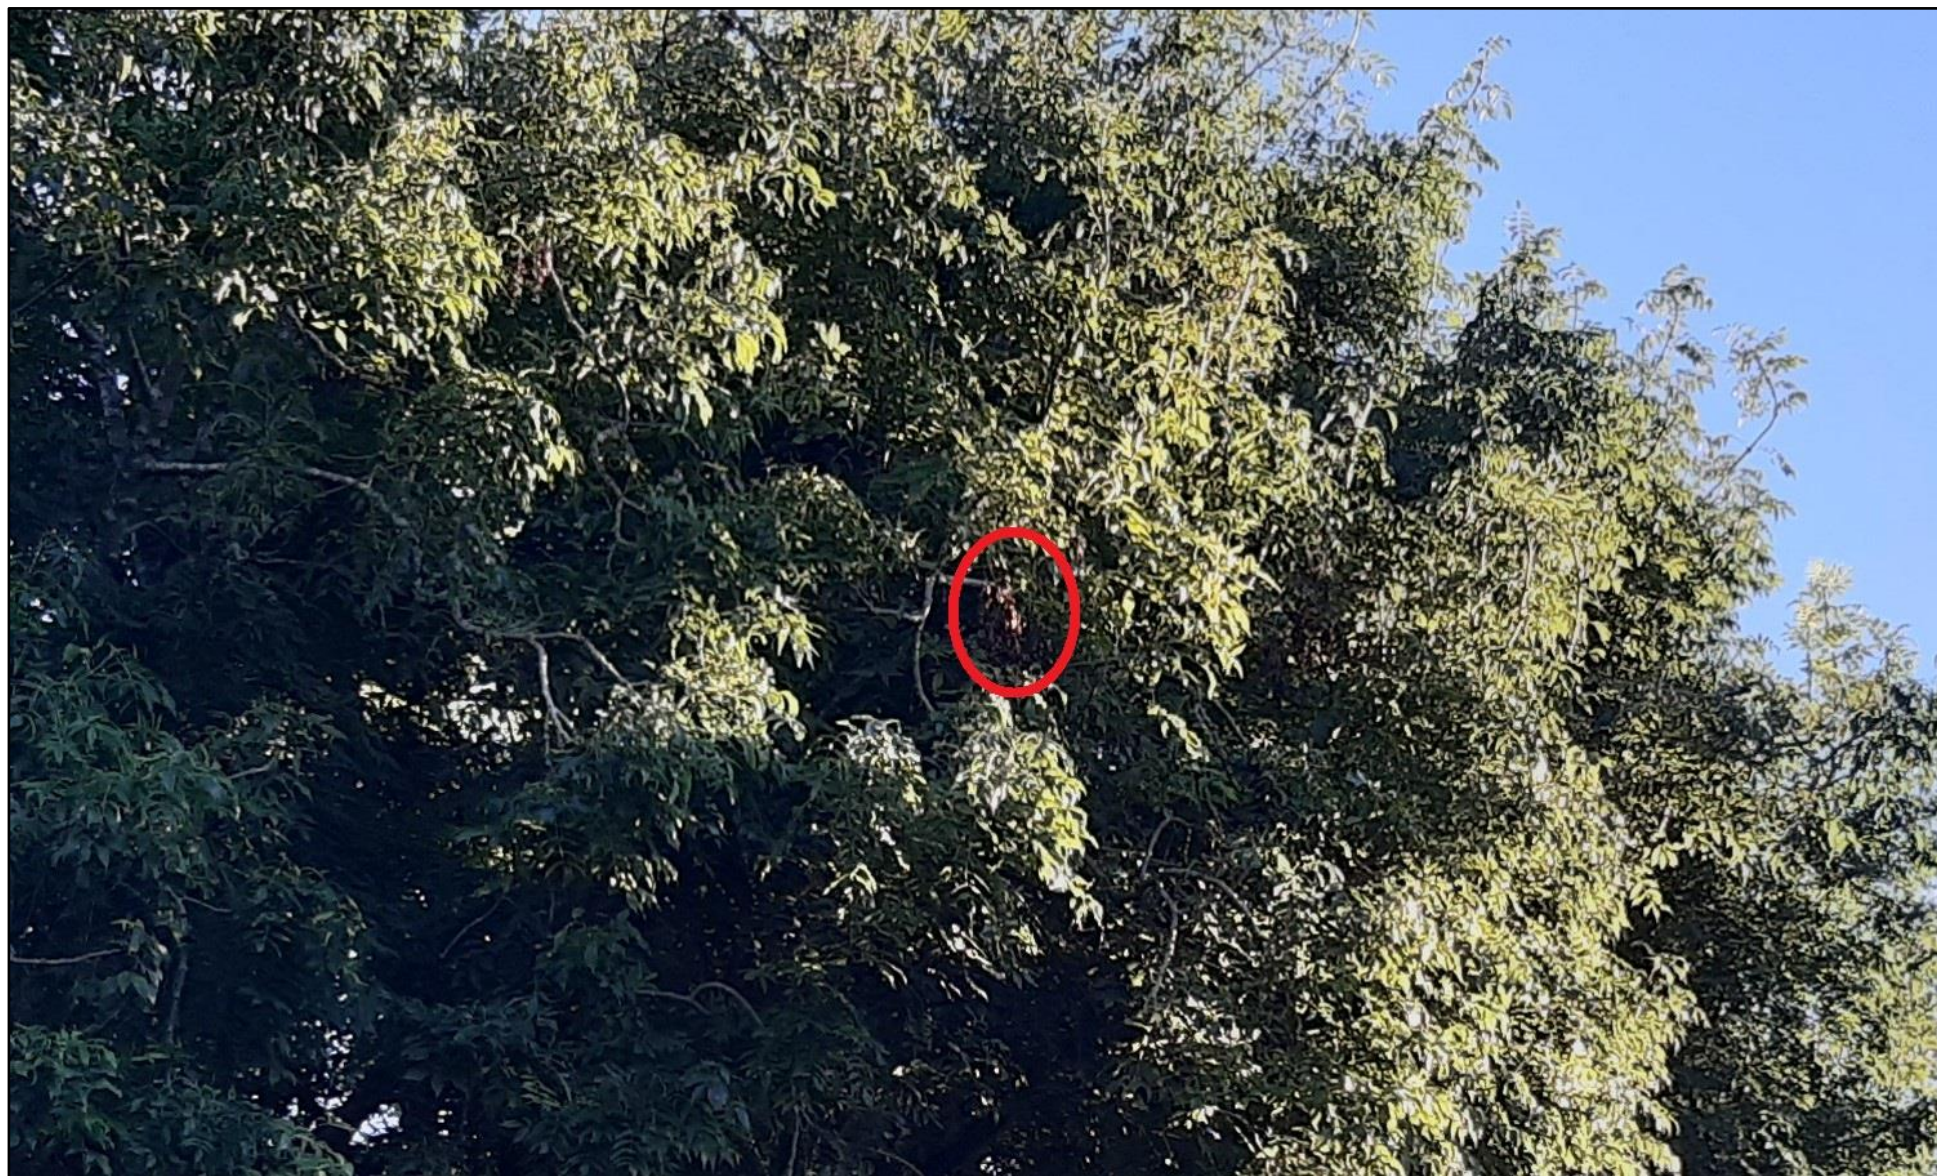
Photo 2 – Blackened withered leaves hanging in the canopy

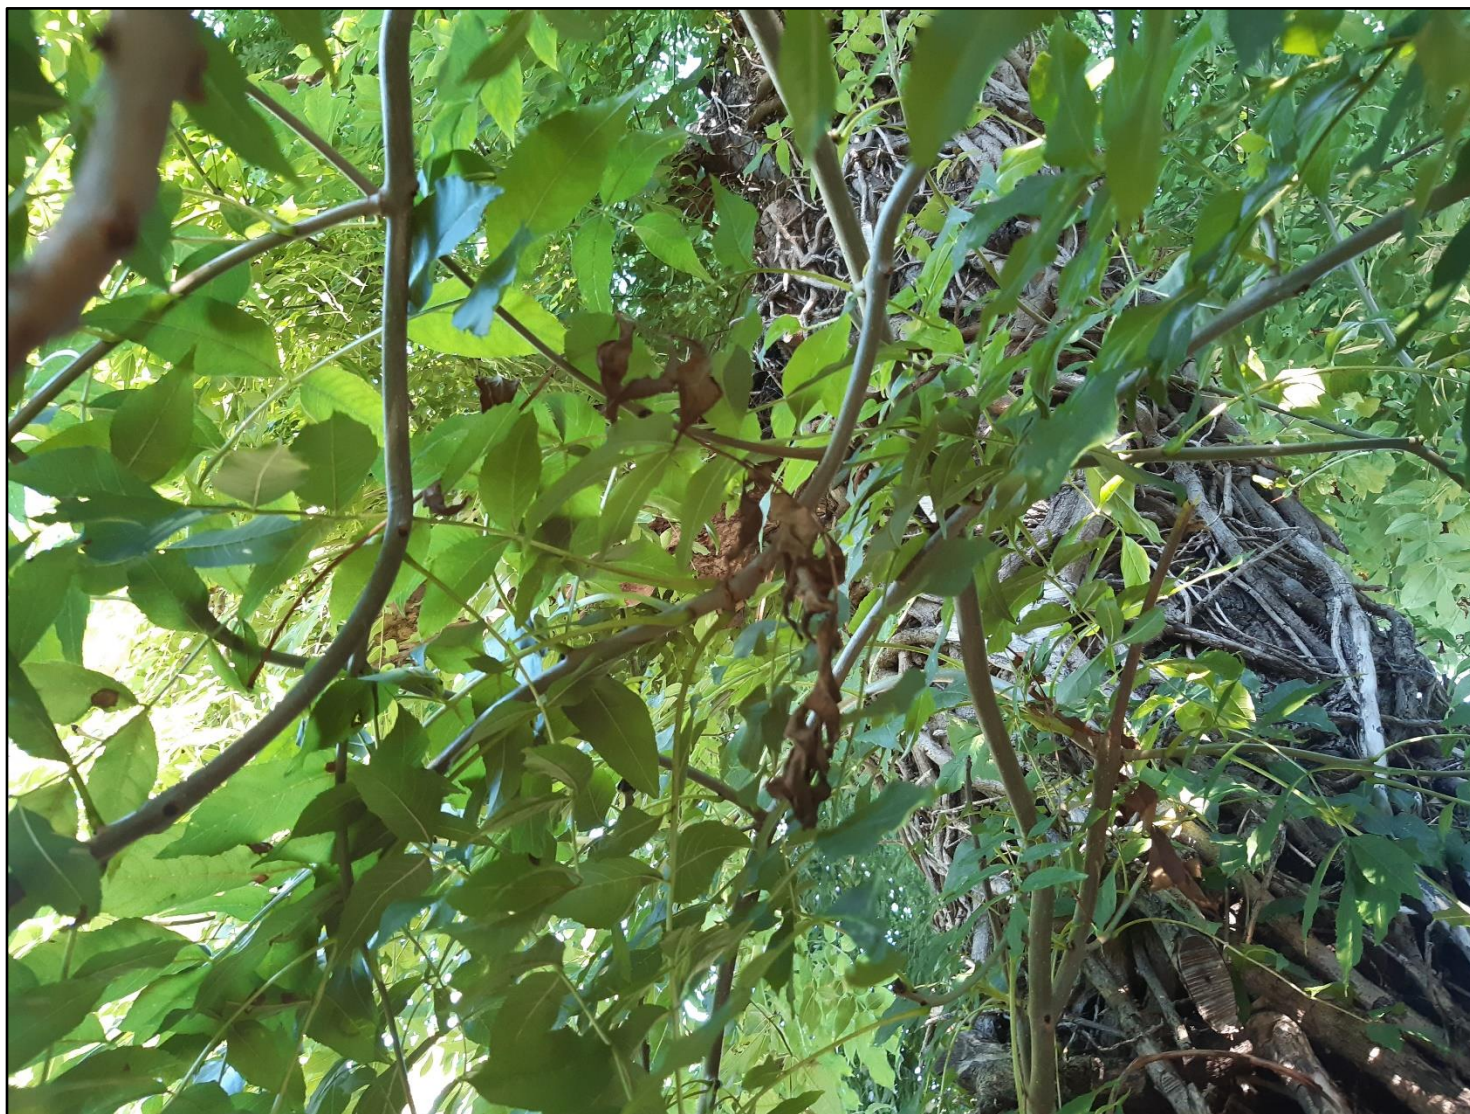
Photo 3 – Blackened withered leaves hanging in the canopy

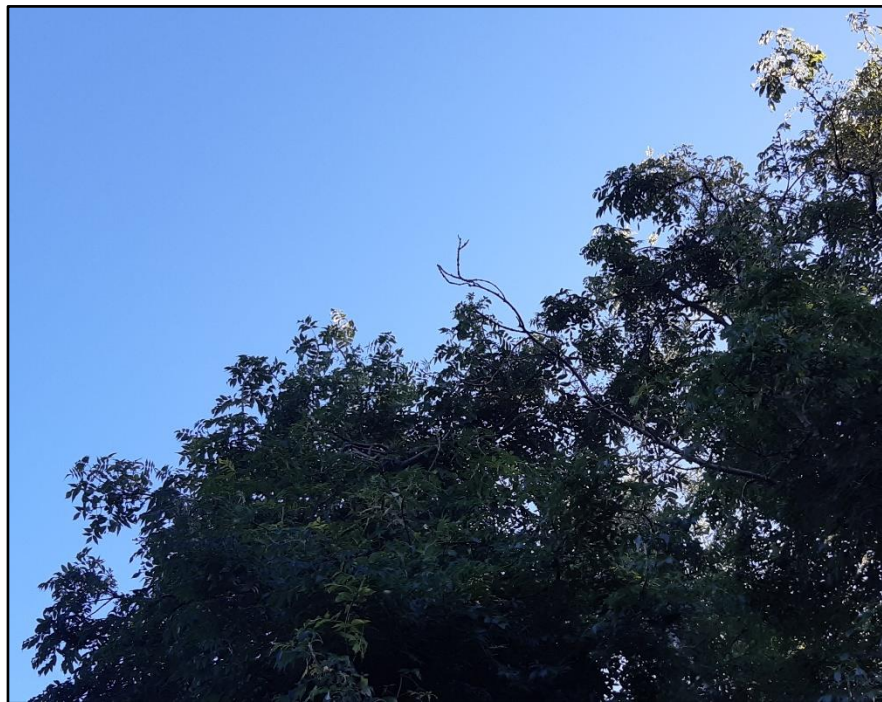
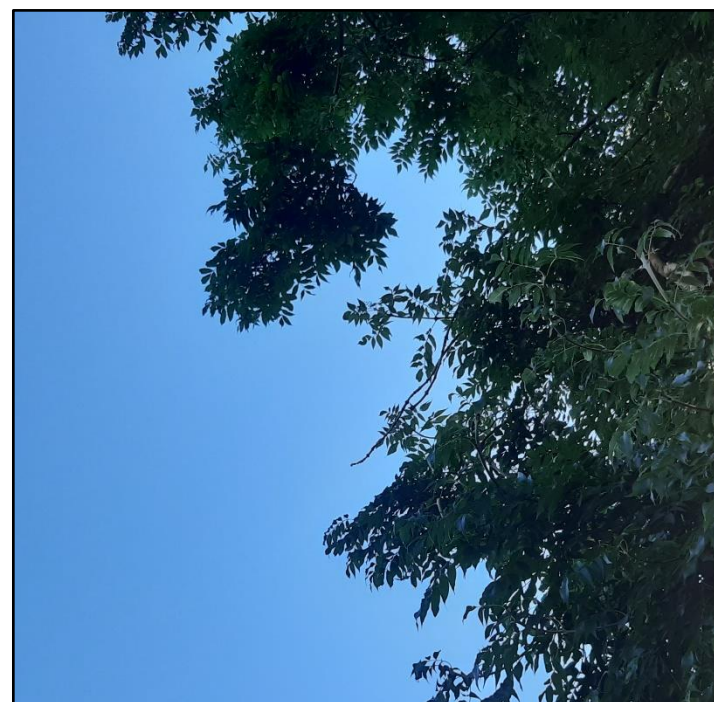
Dieback of terminal shoots is well documented within the photographic record provided by WAC on pages 17 & 18 of '18 Station Road Ash Tree Arboricultural Management Report July 2021'. This was evident during the site visit though to a lesser degree due to this year's growth. Trees under stress will use their energy reserves to put on new growth and maintain photosynthetic function. This gives the impression of a full canopy and a healthy tree to the untrained eye. Unfortunately, this illusion is a thin veneer which will be lost as the pathogen progresses through the tree and the assimilate transport system is further degraded. See photos 4 and 5 in appendix 1.

Photos 4 & 5 – Dieback of shoots in canopy. Displayed more clearly in WAC report of July 2021.

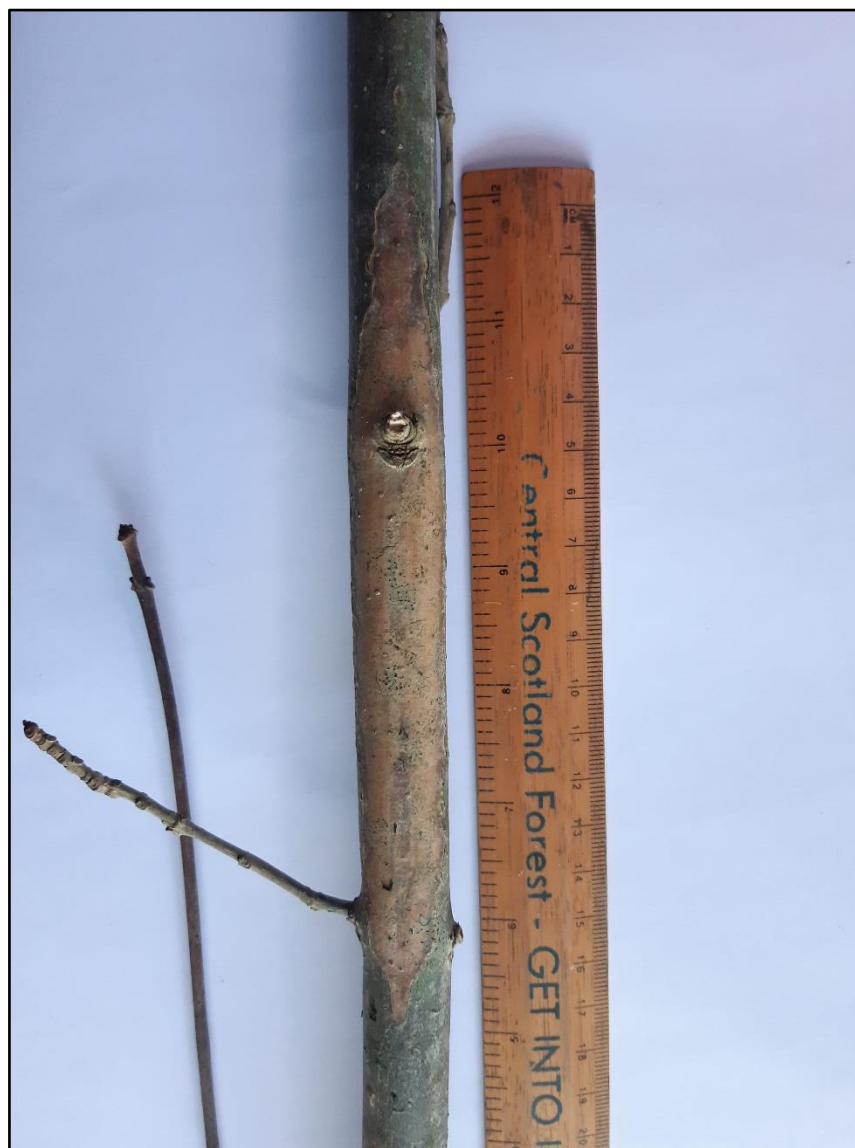
Pole pruners were used to remove a small diameter section of deadwood from the lower canopy. The shoot was arising from one of the historic pruning wounds adjacent to the primary fork union. A characteristic diamond shaped lesion was found on this branch (photo 6, appendix 1). Removal of the bark in the affected area revealed the presence of tiny black lines which are pseudosclerotial plate formation (photo 7, appendix 1). Commonly referred to as spalting, this as a clear indication of the presence of fungal pathogens within the wood structure. Coupled with the blackened withered leaves, the diamond shaped lesion, and dieback of terminal shoots, the presence of ash dieback is obvious and undeniable.

Photo 6 – Characteristic diamond shaped lesion found on trees suffering with ash dieback

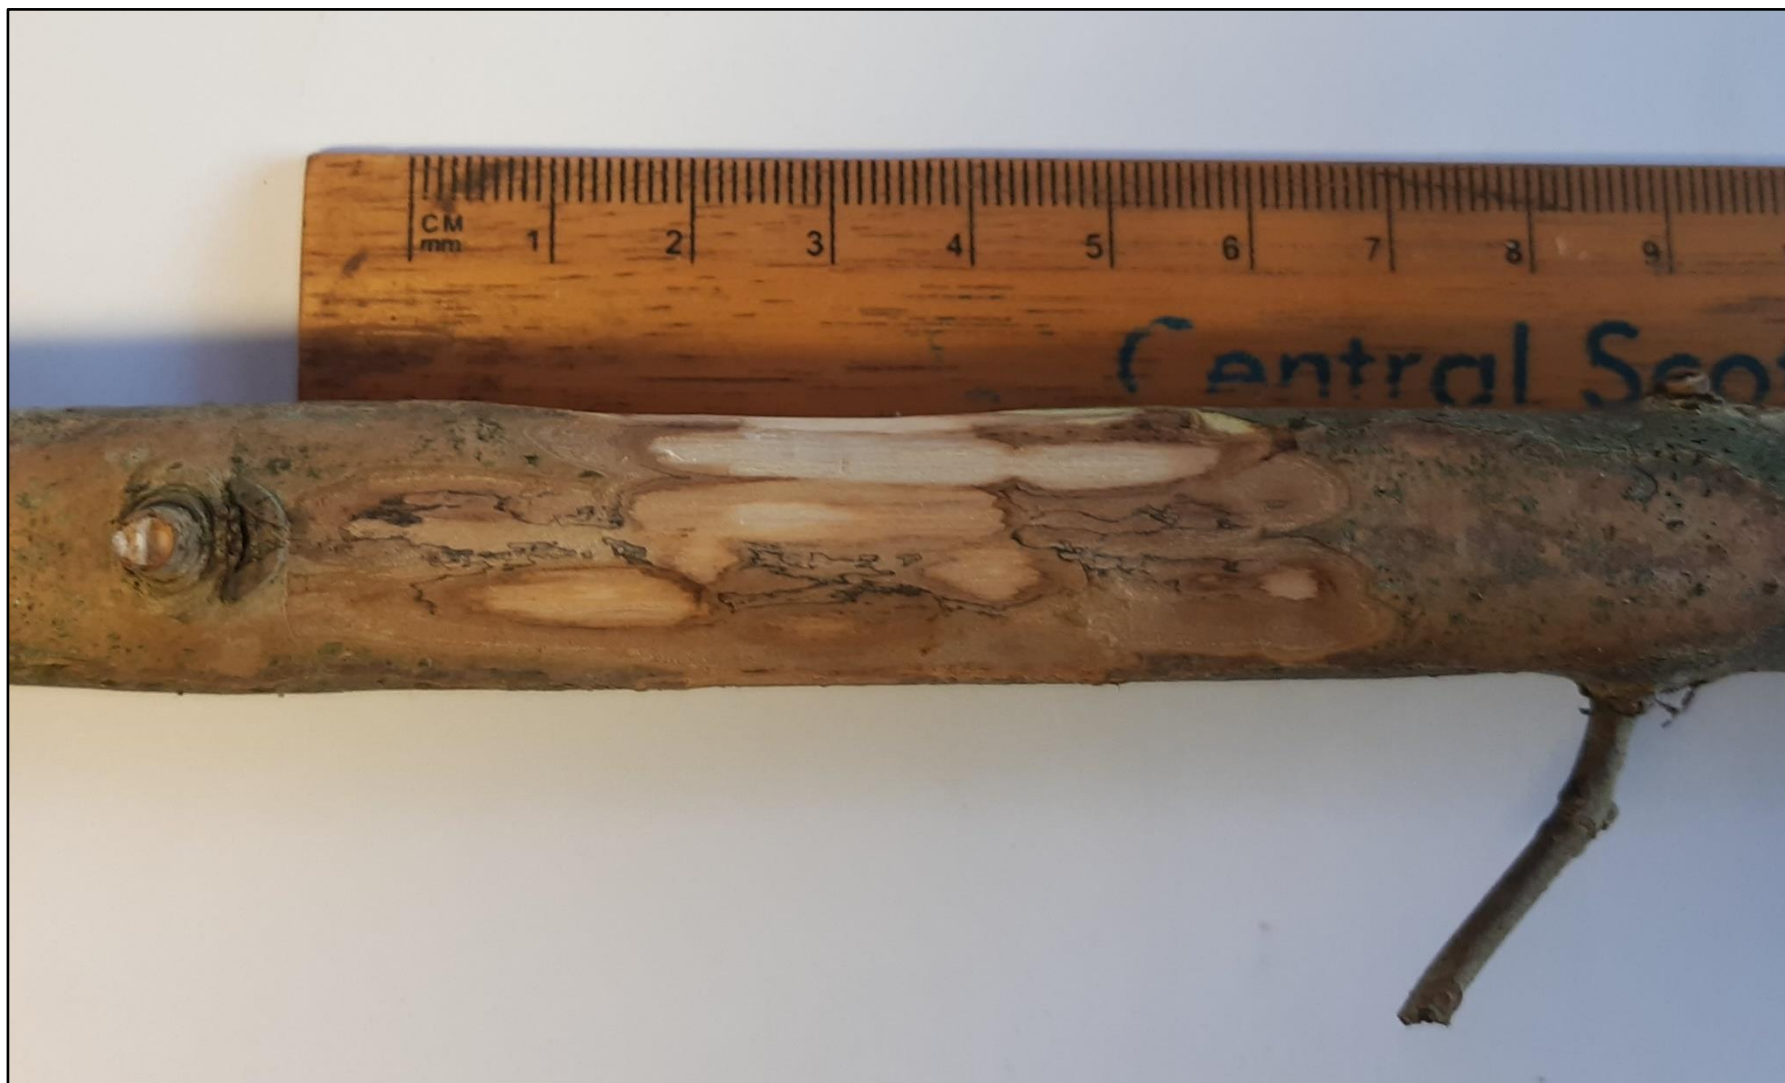
Photo 7 – Exposure of underlying wood structure shows discolouration associated with ash dieback. Delicate black lines are pseudosclerotial plates which confirm presence of fungal pathogen within wood structure.

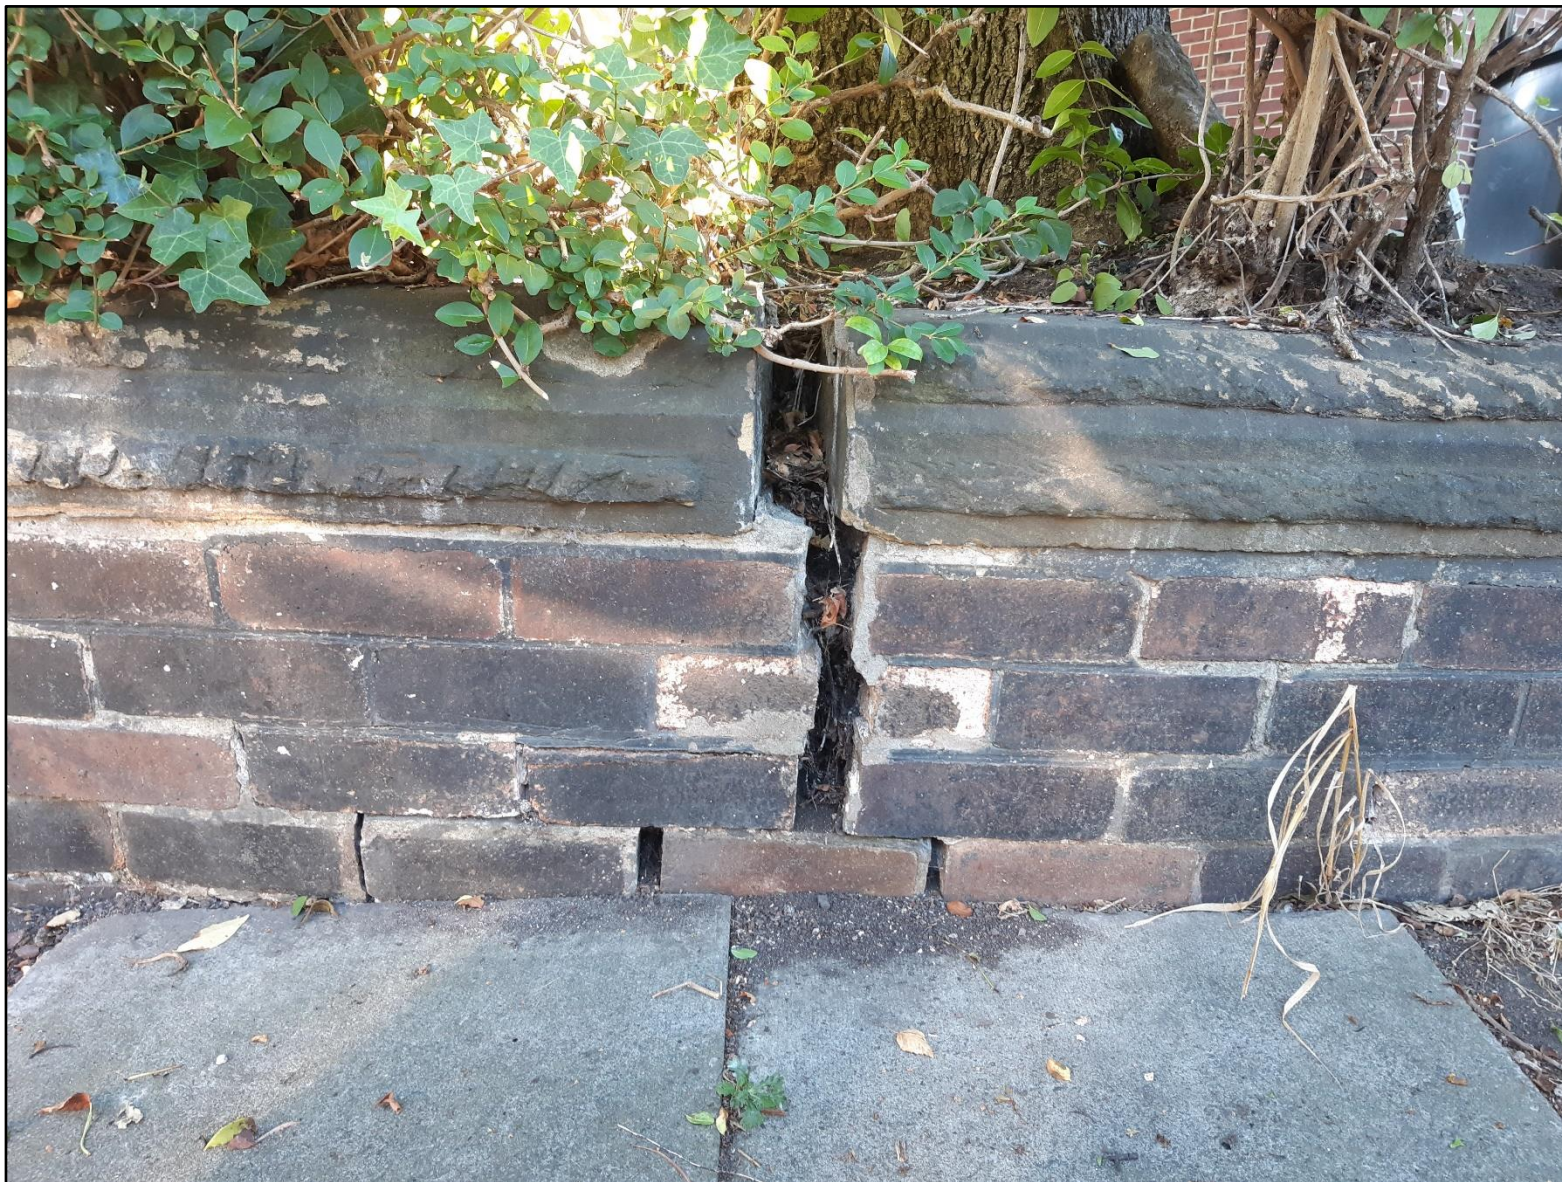
The boundary wall directly adjacent to the tree has a large crack present (photo 8, appendix 1) which is directly attributed to the tree. Works required to make the wall good will further disturb the root system, within 1m of the stem. Given the proximity of the tree to the wall, it is likely that the works will require repeating in the future due to incremental growth of the stem and root system.

Photo 8 – Severe cracking in boundary wall attributed to tree

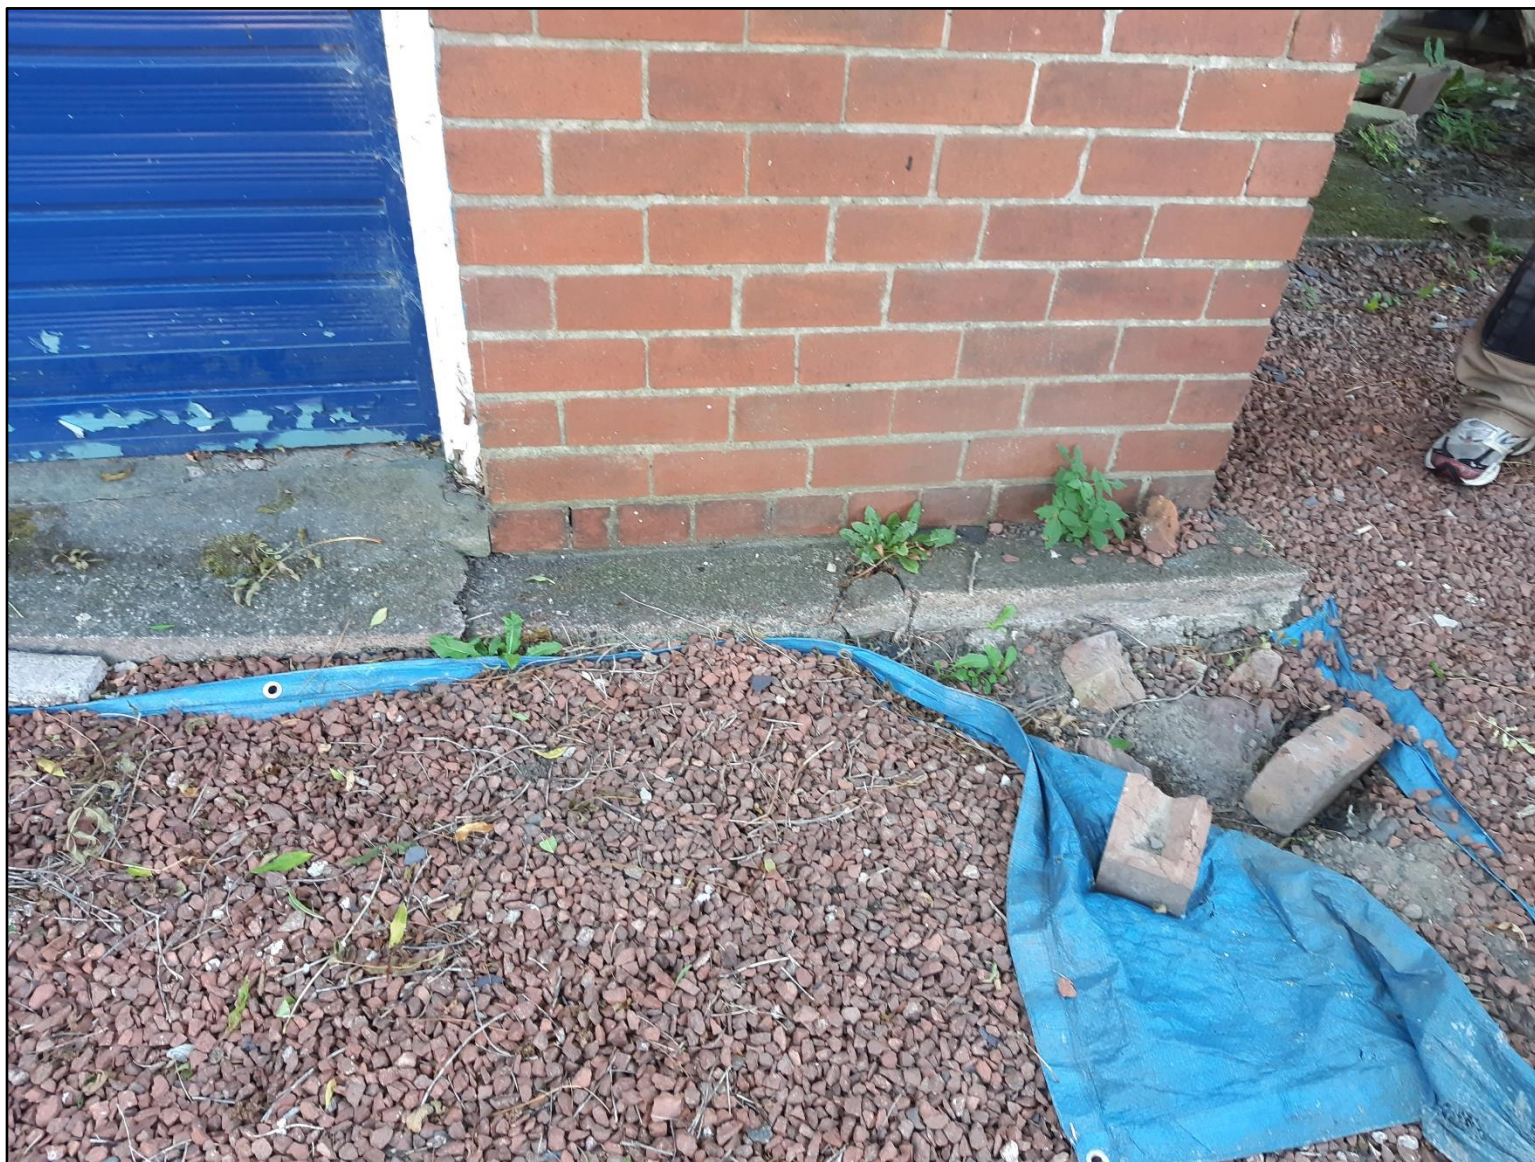
The existing garage is also in a state of disrepair. The concrete pad visible beneath the brick work is cracked and fragmented (photo 9, appendix 1). Additionally, cracking is present from the lintel above the door to the roofline (photo 10, appendix 1) – this is directly above the fragmented concrete pad. This damage is around 4m from the tree stem. It is understood an underground drainage route is located in this area and may have collapsed leading to subsidence of the garage. Relevant professionals have been contacted to conduct investigations but have been unable to do so. The section of underground pipe to be investigated is connected to a T-junction at either end, within third party properties, which prevents remote assessment. It is understood direct excavation into the affected area is required to assess the problem though this has not been undertaken due to potential for damage to the root system. This work is being held in temporary abeyance until a resolution is found, though will become increasingly urgent as the approved planning permission is implemented. Ultimately, following investigation of the underground services, the homeowner would like to locate an access chamber between the tree and building to allow future maintenance. Again, this represents further disturbance to the root system of a mature tree – a degree of damage is unavoidable.

Photo 9 – Cracking & fragmentation of concrete pad

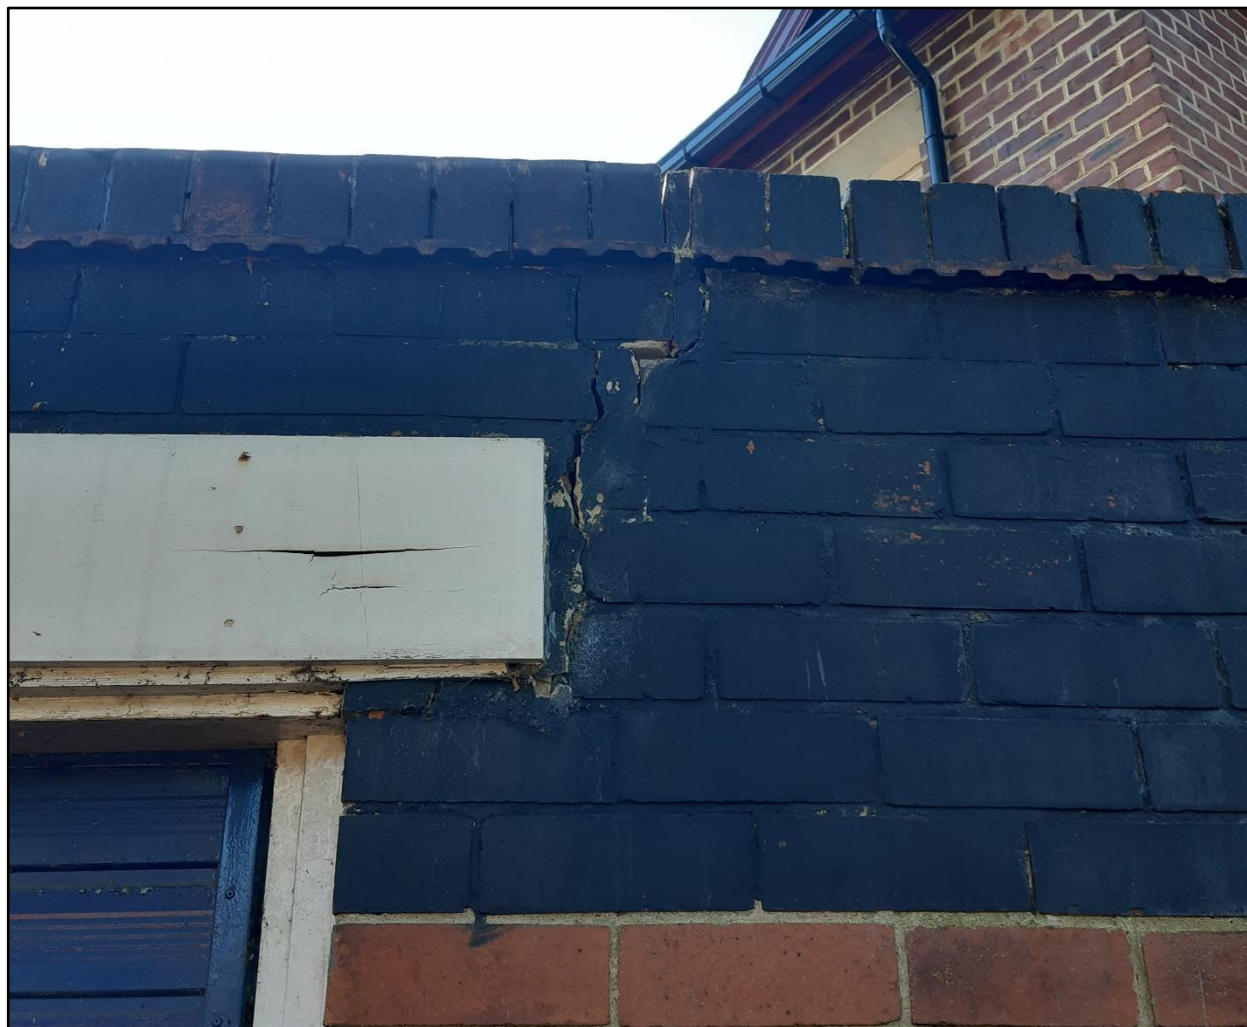
Photo 10 – Cracking adjacent to lintel on garage
