Arboricultural Consultancy for Lloyds Bank

Insured	Mrs Ellen Thomson	Address	Greymartin, Backworth Lane, Newcastle Upon Tyne, NE27 0AL		
Client	Subsidence Management Services	Contact	Manjula Panchal	Claim No.	IFS-LBG-SUB-18-0079347
ES Ref	SA-242385	Consultant	Will Rickerby	Contact No.	0330 380 1036
Report Date	15/01/2019

Scope of Report: To survey the property and determine significant vegetation contributing to subsidence damage, make recommendation for remedial action and assess initial mitigation and recovery prospects. The survey does not make an assessment for decay or hazard evaluation.

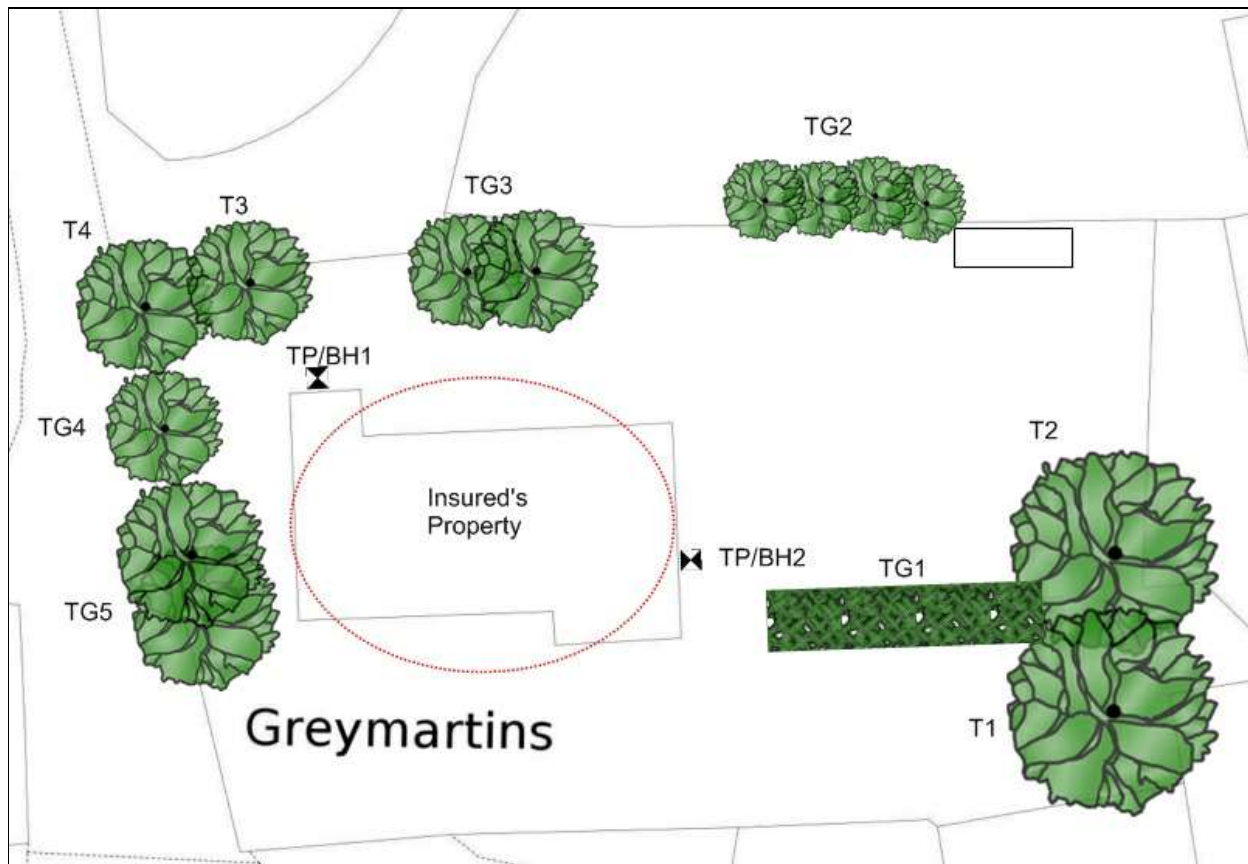
7. Site Plan

With regards to the Pomoideae group roots, it is our opinion that these roots will emanate from minor vegetation located proximate to site of TP/BH1. Given the size / proximity of additional vegetation and the extent of the observed movement, we do not consider that any onsite members of the Pomoideae group represent a material consideration in the current subsidence event.

However, whilst not positively implicated by root analysis, given its size and proximity, TG5 (Acer) cannot be discounted as contributing to the overall level of soil drying proximate to the area of damage and is therefore also considered to retain a contributory influence.

The size and proximity of this vegetation is consistent with the location of damage and advised mechanism of movement.

In order to mitigate the current damage and allow soils beneath the property to recover to a position such that an effective engineering repair solution can be implemented we recommend a program of management as listed by this report.
